Turkey Building Damage Assessment

Overview

After the earthquake in Turkey on February 6th, our team began to utilize artificial intelligence (AI) methods and high-resolution satellite imagery to assess the extent of damage to buildings in the affected region. Specifically, we partnered with Turkey's Ministry of Interior Disaster and Emergency Management Presidency (AFAD) to deliver building level damage estimates over four cities in southeast Turkey using satellite imagery from the first 3 days of the disaster. We estimate 3,849 buildings were damaged/destroyed across the four cities. We found the city of Marash* to be the most heavily affected, with 7.44% of buildings in the city sustaining some level of damage visible from satellite imagery.

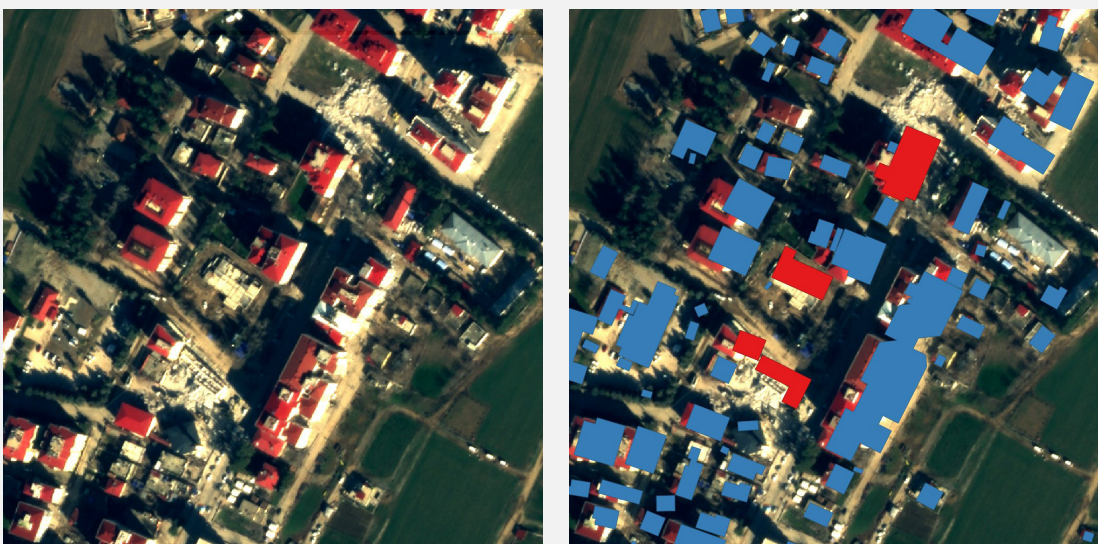
We found that damage in the city of Turkoglu was distributed throughout the city with fewer large clusters of damage (as compared to the other AOIs). In total, 4.85% of the buildings in the city were damaged, affecting an estimated 6,202 people. Figure 5 shows an example of two destroyed apartment buildings along one of the major streets through the city.

Figure 5: Several destroyed apartment buildings in Turkoglu. Planet Labs PBC, Feb 9th.

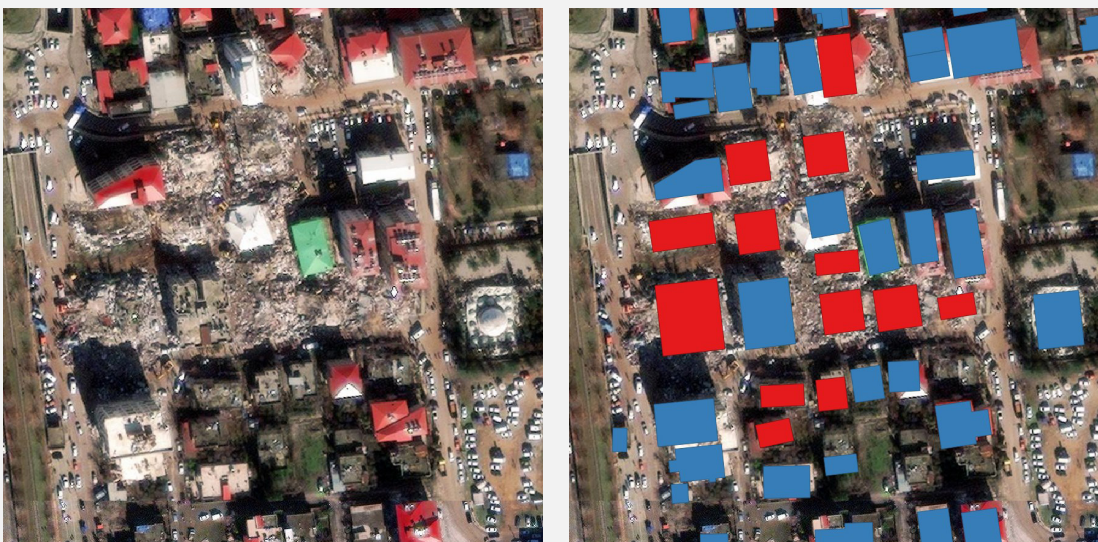
We found 13,215 damaged buildings in Islahiye, representing 2.48% of the total number of buildings. By the percentage of damaged buildings Islahiye was the least affected out of the four study areas, however we observed that the damaged buildings were clustered in more densely populated areas. For example, Figure 7 shows a group of nine apartment buildings that were all destroyed. Even though similar numbers of buildings were destroyed between Islahiye and Nurdagi, we estimate over one thousand more people were affected in Islahiye.

Figure 7: A set of nine destroyed 5-story apartment buildings in downtown Islahiye. Maxar Technologies, Feb 7th.

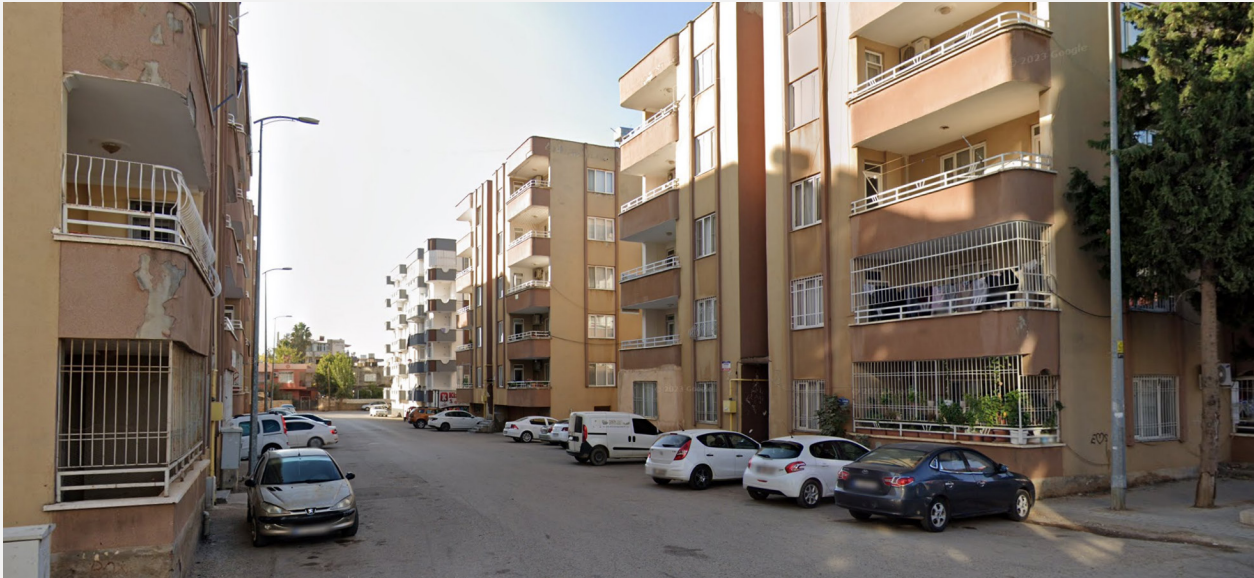
Figure 8. Pre-disaster Google Street View imagery from Islahiye of the destroyed apartments shown in Figure 7.
